## 663i Boost Pipe Upgrade

Item: DBR-BG01288072

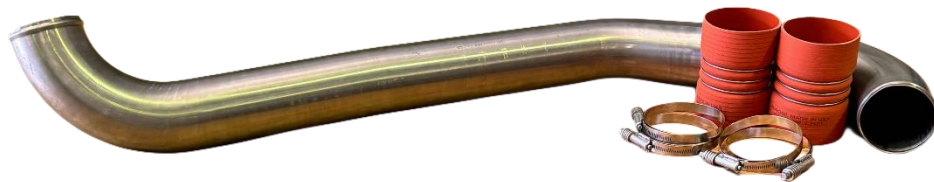
1. Prior to tagging out the truck, please carry out a brake test to confirm there is sufficient boost pressure before installing the upgrade.
2. Ensure the truck is parked on flat, level ground and that the correct tagging/isolation procedures are followed.
3. Remove the air intake Y piece & turbo lagging.
4. Completely remove the OEM silicone boost hoses & steel pipe.
5. Install the D.B.R stainless steel boost pipe using straight silicone joiners, as shown in the picture below.

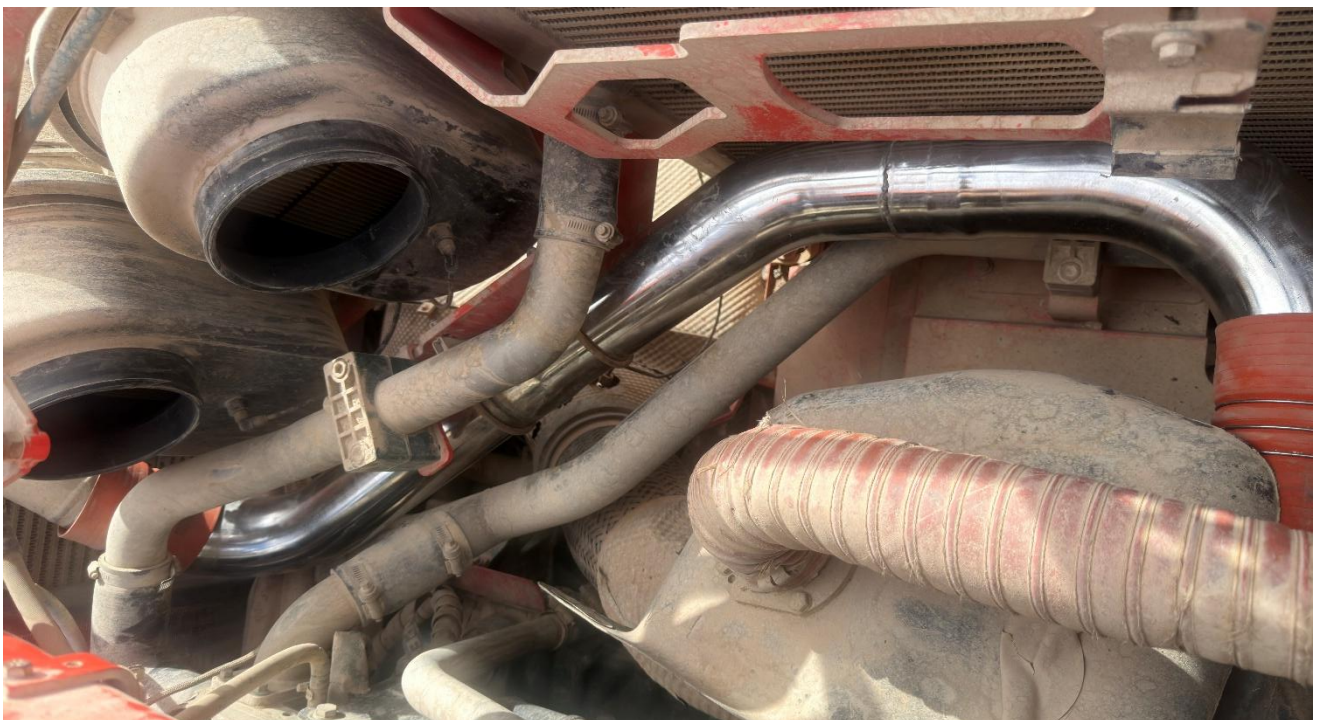
**Note 2:** The expansion join closest to the cooler end should sit between the U-bolts. This prevents the pipe from sliding under load.

6. Please make the following adjustments (only if required); loosen off, spin & then resecure the turbo snail whilst the pipe is loose in the U-bolts to ensure there is a good orientation, between the turbo outlet & the intercooler, as seen in the above photo.

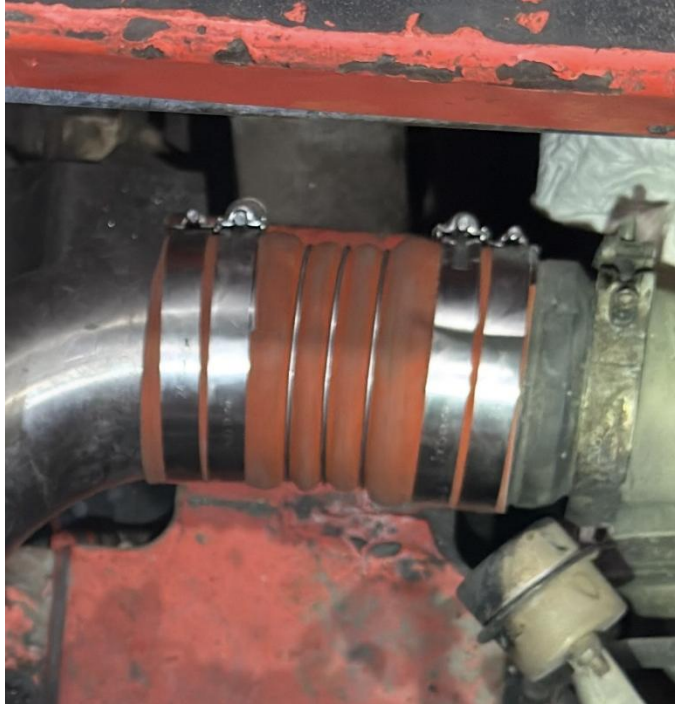
7. Secure the silicone hoses using the supplied hose clamps. Please double clamp, then tighten the mounting U-bolts. See below picture.

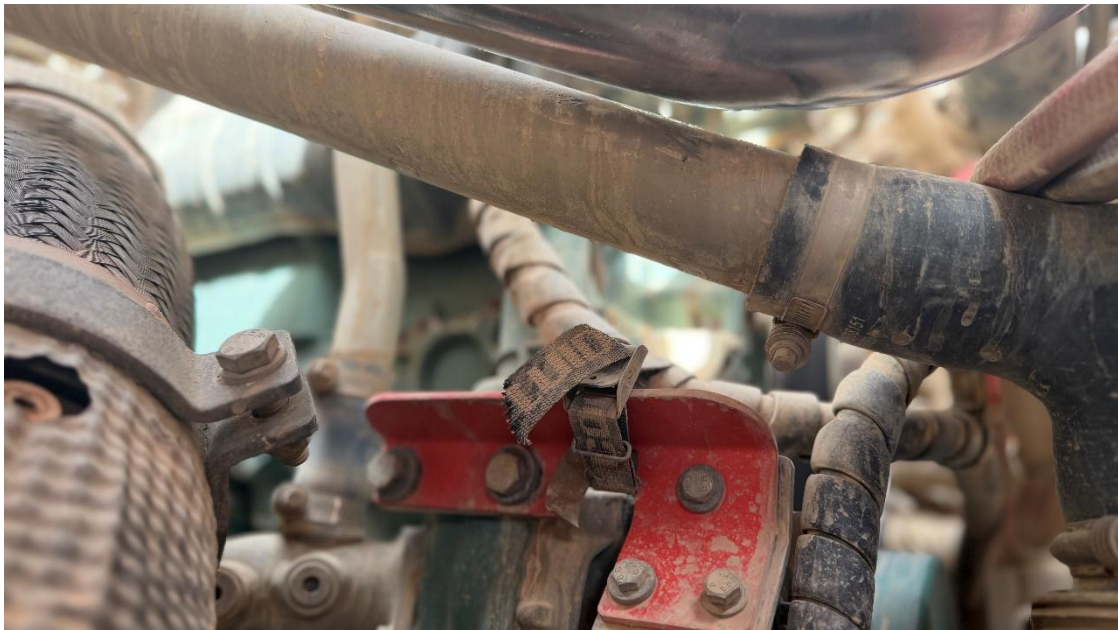
8. Please ensure there is a small gap between the cooling pipe and the boost pipe, as seen in the below picture. This adjustment is not always required, but can be achieved by adjusting the U-bolt to truck frame mounting plate.

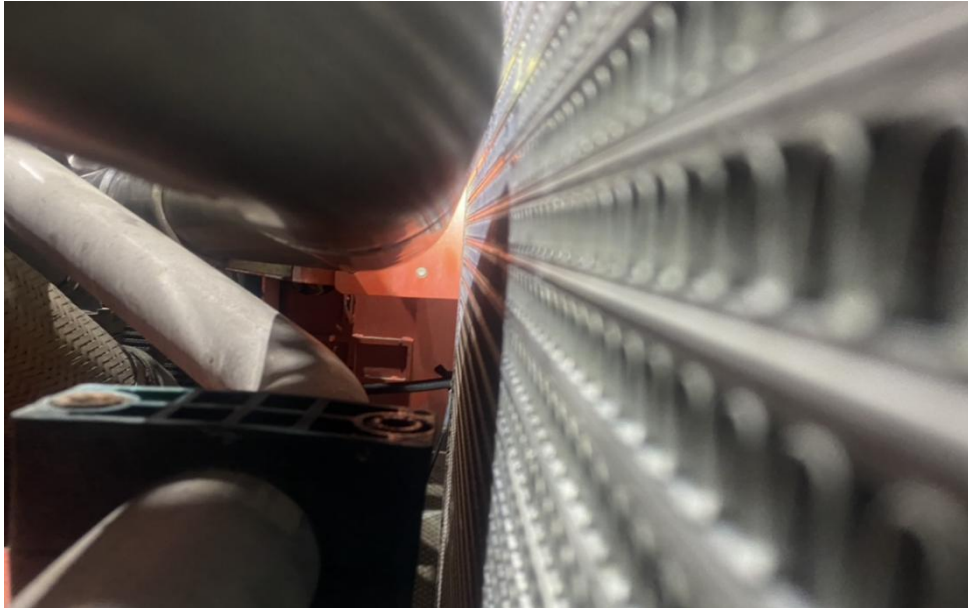
9. Please ensure there is a gap between the boost pipe & the side cooler, as seen in the below picture.
